Citizens' Oversight Projects (COPs)

QUESTIONS FROM CITIZENS OVERSIGHT PROJECTS (COPS) REGARDING STEAM GENERATOR TUBE FAILURES AT SAN ONOFRE NUCLEAR GENERATING STATION

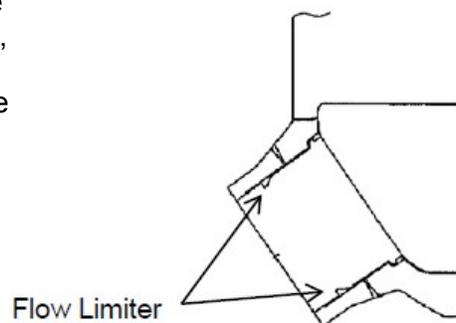
Flow Limiter for Primary Inlet Nozzles – The replacement steam generators were designed with a flow limiter located in the primary inlet nozzle (see figure below) in order to make the reactor coolant system flow similar to the flow rate of the original steam generator and not exceed the maximum allowable reactor coolant system flow rate. The licensee's evaluation for the engineering design package determined that although the original steam generators had a number of plugged tubes, the reactor coolant system flow rate of the original steam generators was near the design requirement. Because the

replacement steam generators has 377 more tubes than the original steam generators, and contained tubes with u-bends versus “square bends”, the pressure drop of the replacement steam generators with no plugged tubes would be much less than the original steam generators resulting in a higher flowrate.

The flow limiter was designed to ensure the total “best estimate” reactor coolant flow rate with the replacement steam generators installed would not exceed 106.5 percent of the design volumetric flow rate of 396,000 gallons per minute at a reactor coolant system cold leg temperature of $T_{cold} = 540.9^{\circ}F$. For Unit 2 replacement steam generators, the flow limiter diameter to nozzle inner diameter ratio was 0.94 while the ratio for Unit 3 steam generators was 0.915 due to Unit 3 reactor coolant pump replacement. The flow limiter dimensions resulted from a scaled model test performed by Mitsubishi and it was designed to be machined as part of the nozzle base metal.

On page 30 of the NRC AIT Report, there is a discussion of the flow limiters:
